# Incorporating Phase I Environmental Site Assessments into the HUD Environmental Review

February 22, 2023

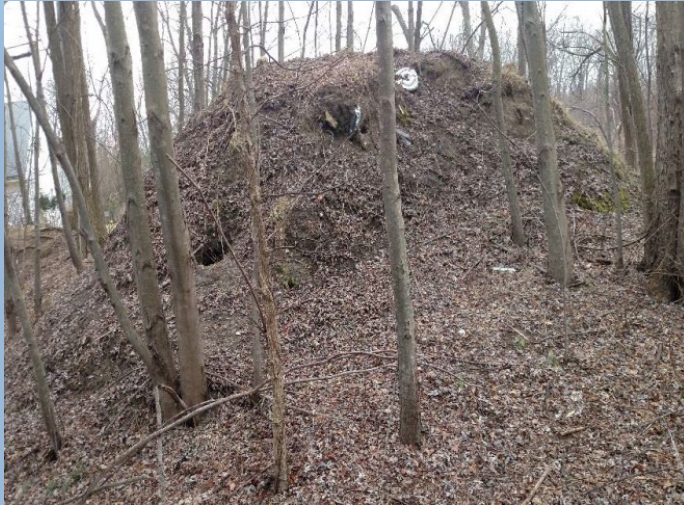
**Photo 1:** A dirt pile found at the northwest corner of the Site

The Site is an undeveloped lot with numerous deciduous trees. The ground is covered with vegetation, but piles of tires, concrete and asphalt debris are present in several areas throughout the Site. A partially constructed road and sewer improvements were observed cutting through the Site at the southern Site border to the Site's north border. Based on the condition of the road and the vegetation in and around it, this road has been unfinished and abandoned for several years.

**Waste disposal areas** (dumps, landfills, etc.) were identified at the Site during the PA/ESA. **Piles of tires**, a pile mixture of concrete, soils, and **asphalt** were observed on Site.

Several piles of concrete asphalt and dumped soils were observed at the Site. Near the northeast corner of the Site, an approximately 600 square foot pile of asphalt and soil was observed. A similar pile was observed adjacent to the southern end of the unfinished roadway. These two piles are **assumed** to be related to the aborted roadway construction. None of the piles are suspected to contain contaminants at levels exceeding the applicable remediation standards and no further remediation is required. However, **all of the piles should be properly disposed.**
