April 20, 2015

Adapt Project No. WA15-19965-PH1

Subject: Phase I Environmental Site Assessment
Auto Tire and Service Property
3501 Rainier Avenue South
King County Parcel Numbers 7879400125 and 7879400140
Seattle, King County, Washington 98144

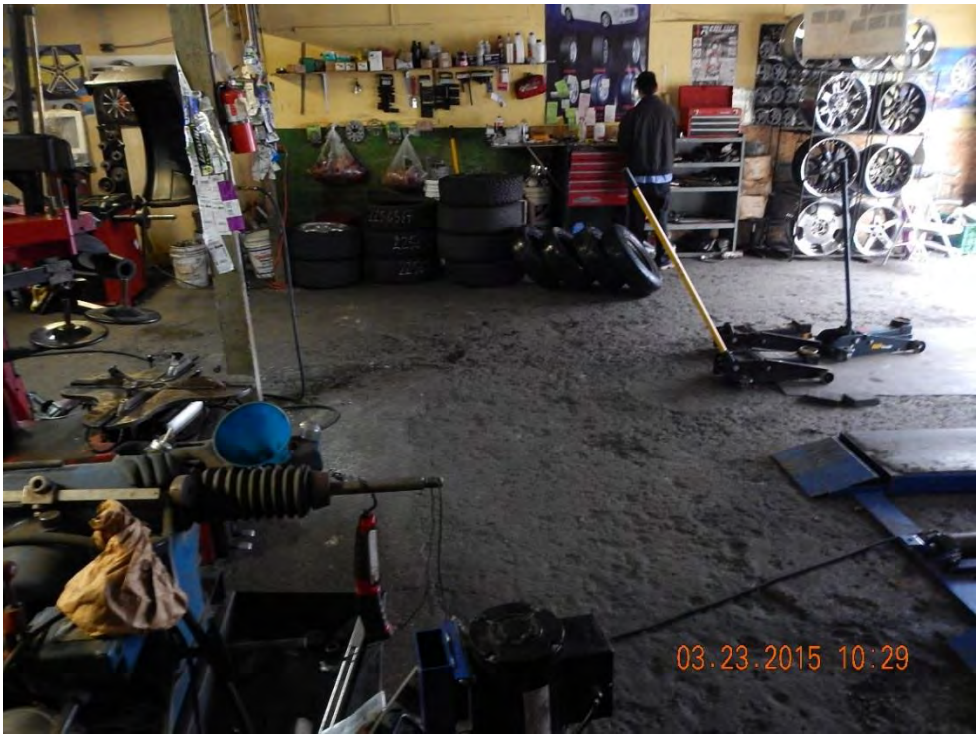
3. Looking southwest into the garage/shop area, currently used for tire service.

4. Interior view of the southern portion of the garage/shop area.
